MEGUNTICOOK RIVER BASIN
CAMDEN, MAINE

KNOX MILL DAM
ME-00276

PHASE I INSPECTION REPORT
NATIONAL DAM INSPECTION PROGRAM

AUGUST 1978

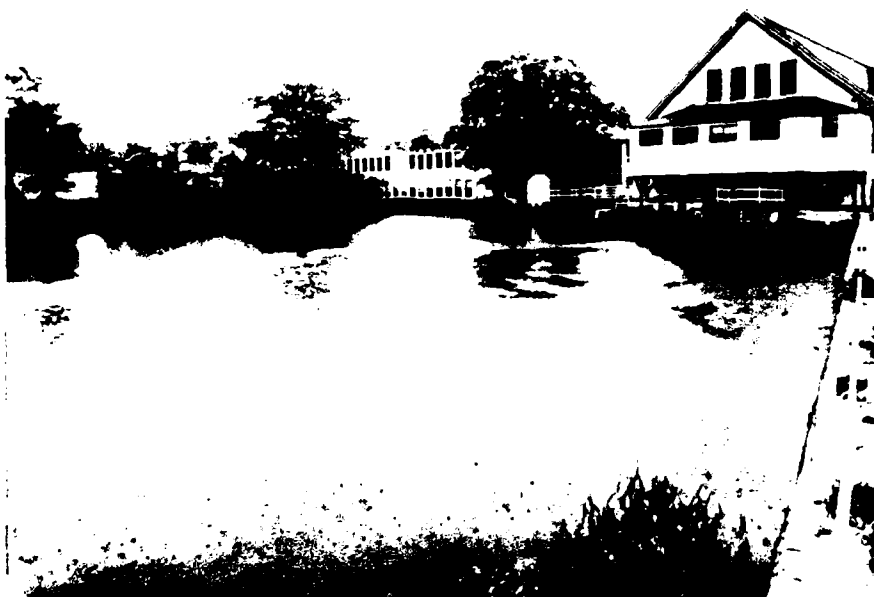
K-1

VIEW OF DAM FROM UPSTREAM

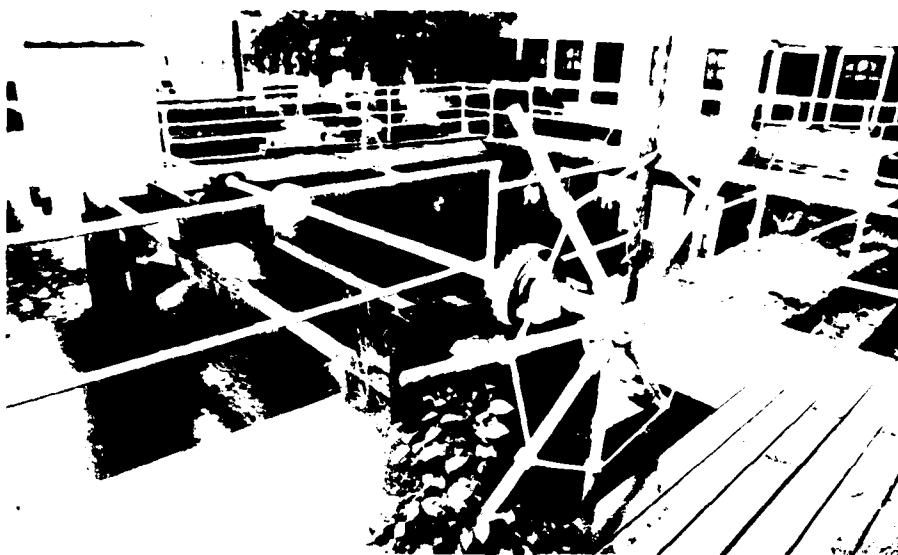
K-3

b. Operating and Emergency Control Gates. The regulated outlet gate is a timber vertical lift gate operated manually by a rack and gear. The operating equipment appeared to be in good condition. See photograph K-3.

GATEHOUSE AND CONTROL WHEEL

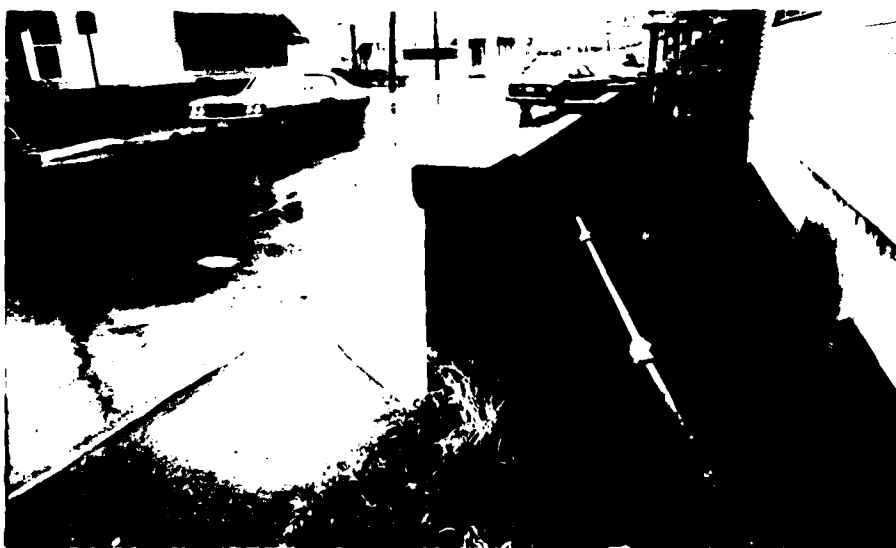
K-4

OUTLET AT DOWNSTREAM SIDE OF KNOX MILL FACTORY BUILDING

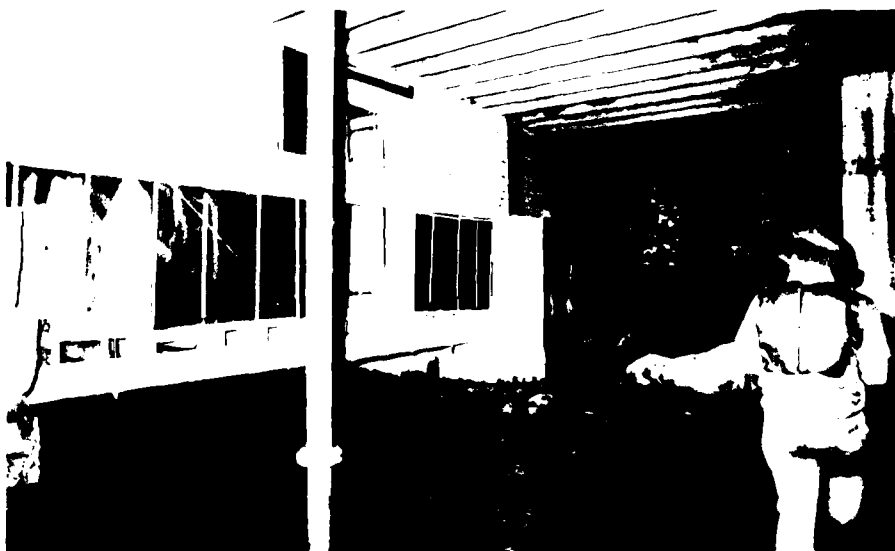
K-5

VIEW OF SHOP OVERHANG IN NUMBER 1

SLUICeway UNDER KNOX MILL
